**NASA CONTRACTOR  
REPORT**

NASA CR-2884

**LOAN COPY: RETURN TO  
AFWL TECHNICAL LIBRARY  
KIRTLAND AFB, N. M.****MODEL PREDICTIONS OF WIND  
AND TURBULENCE PROFILES  
ASSOCIATED WITH AN ENSEMBLE  
OF AIRCRAFT ACCIDENTS**

AERONAUTICAL RESEARCH ASSOCIATES OF PRINCETON, INC.

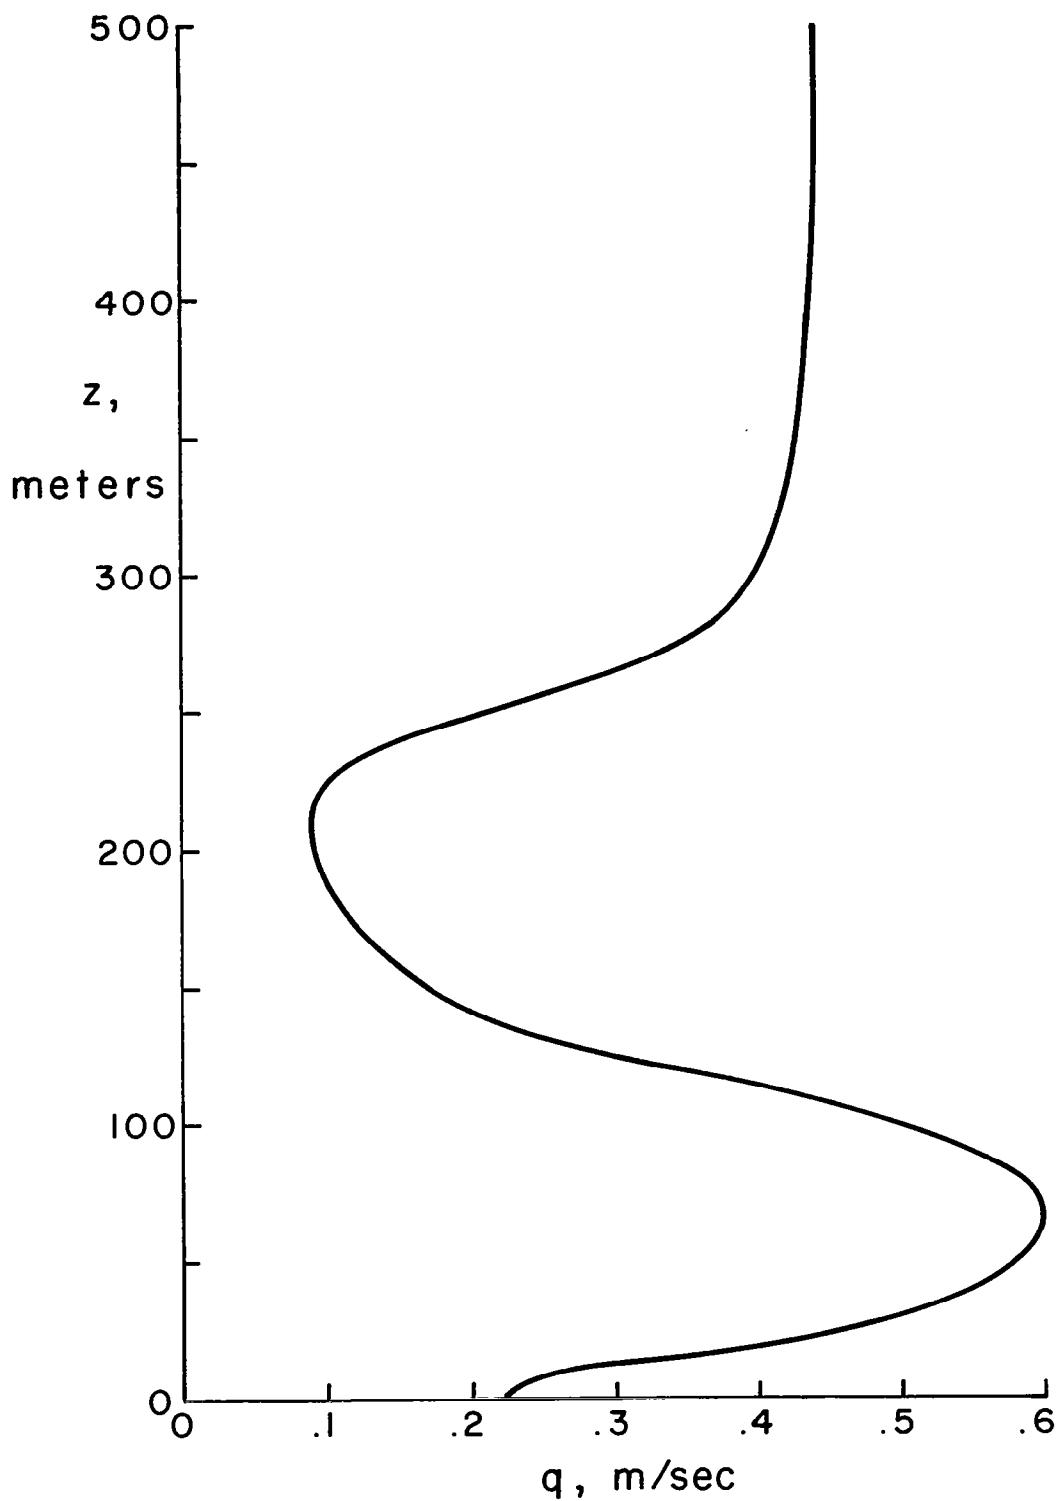
Figure 3.2.10. Altitude profile of variance of the total velocity for Boston, December 17, 1973 accident.

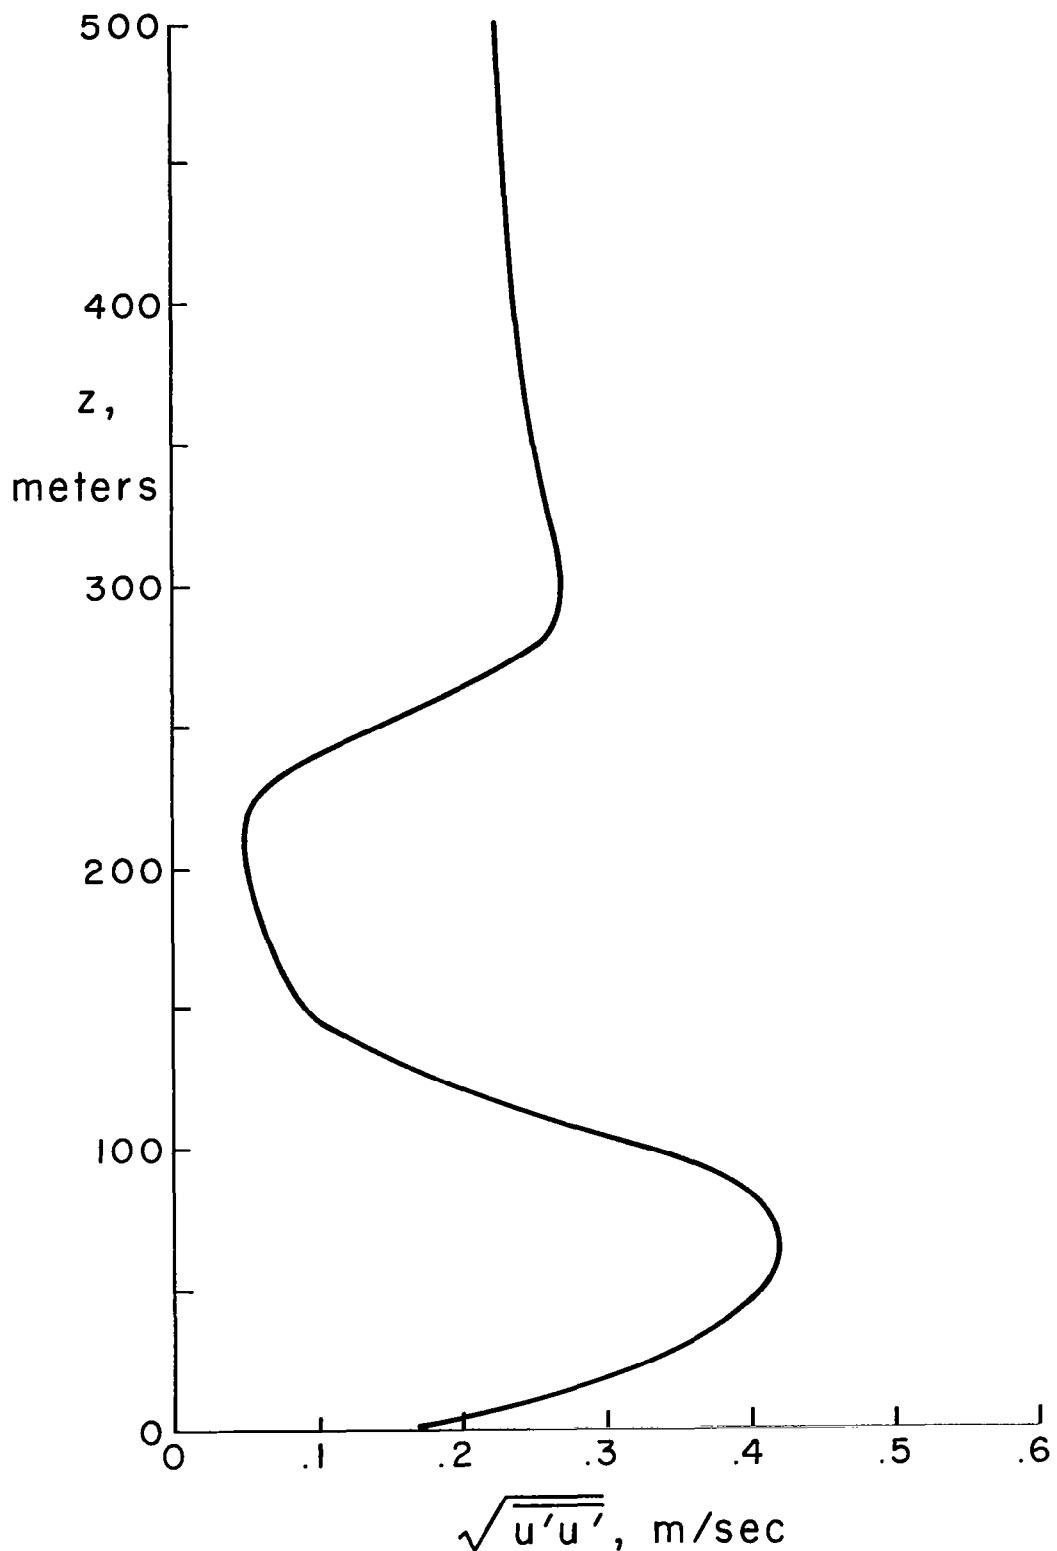
Figure 3.2.11. Altitude profile of variance of the wind parallel to runway for Boston, December 17, 1973 accident.

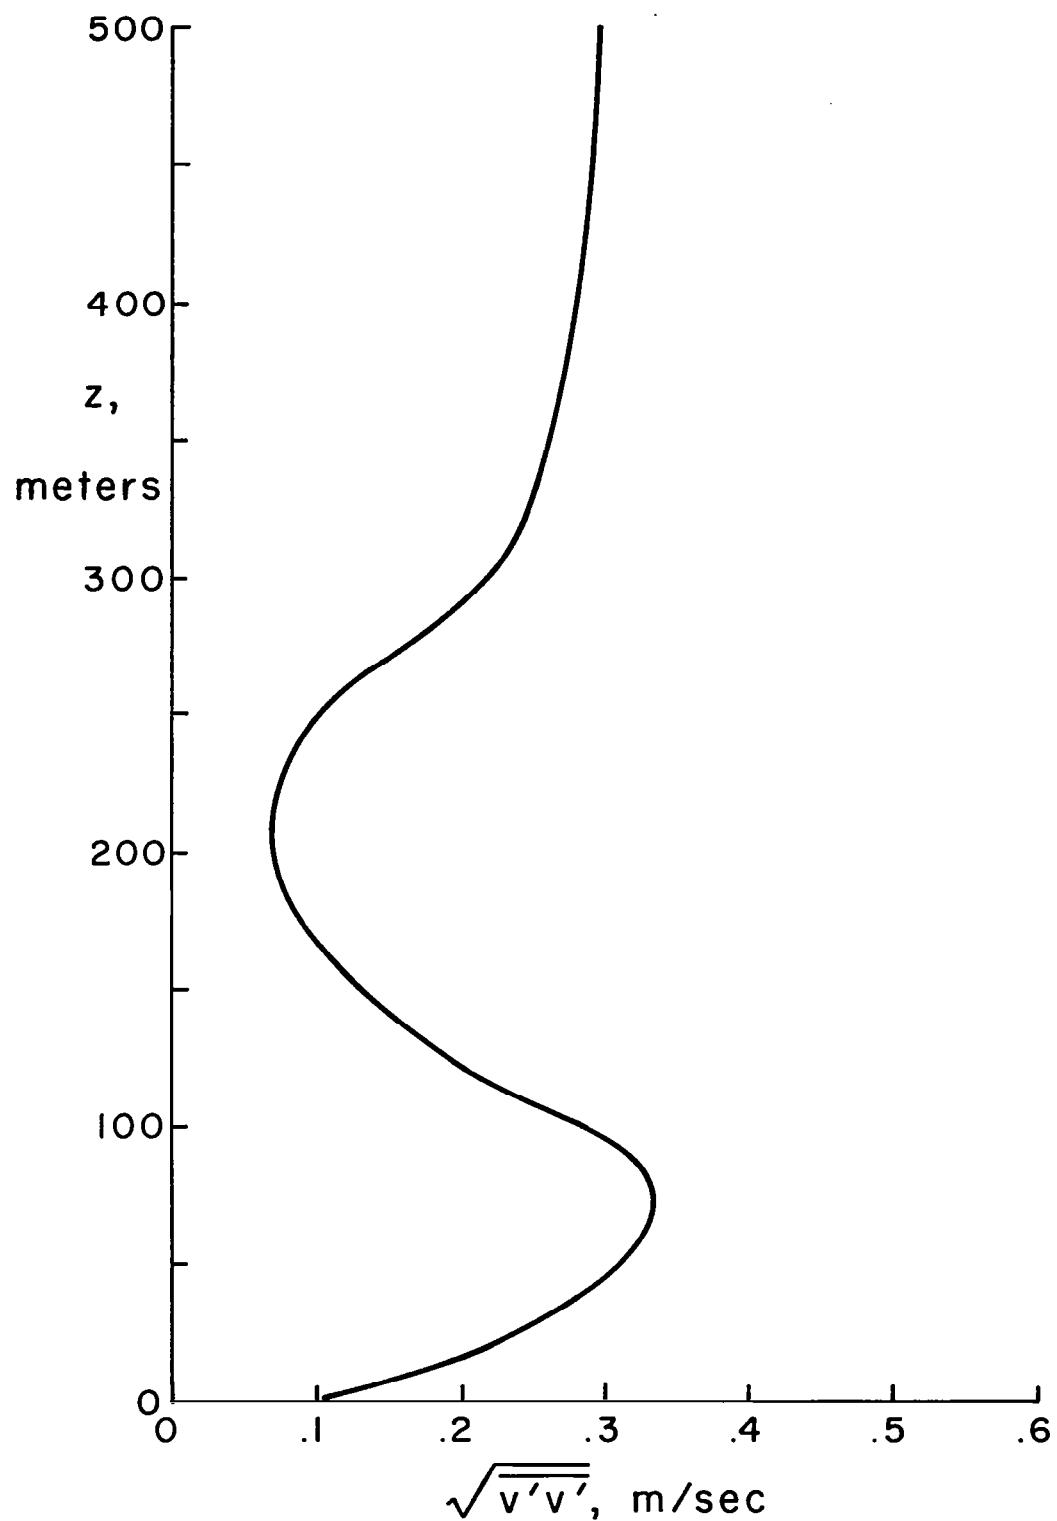
Figure 3.2.12. Altitude profile of variance of the wind perpendicular to runway for Boston, December 17, 1973 accident.

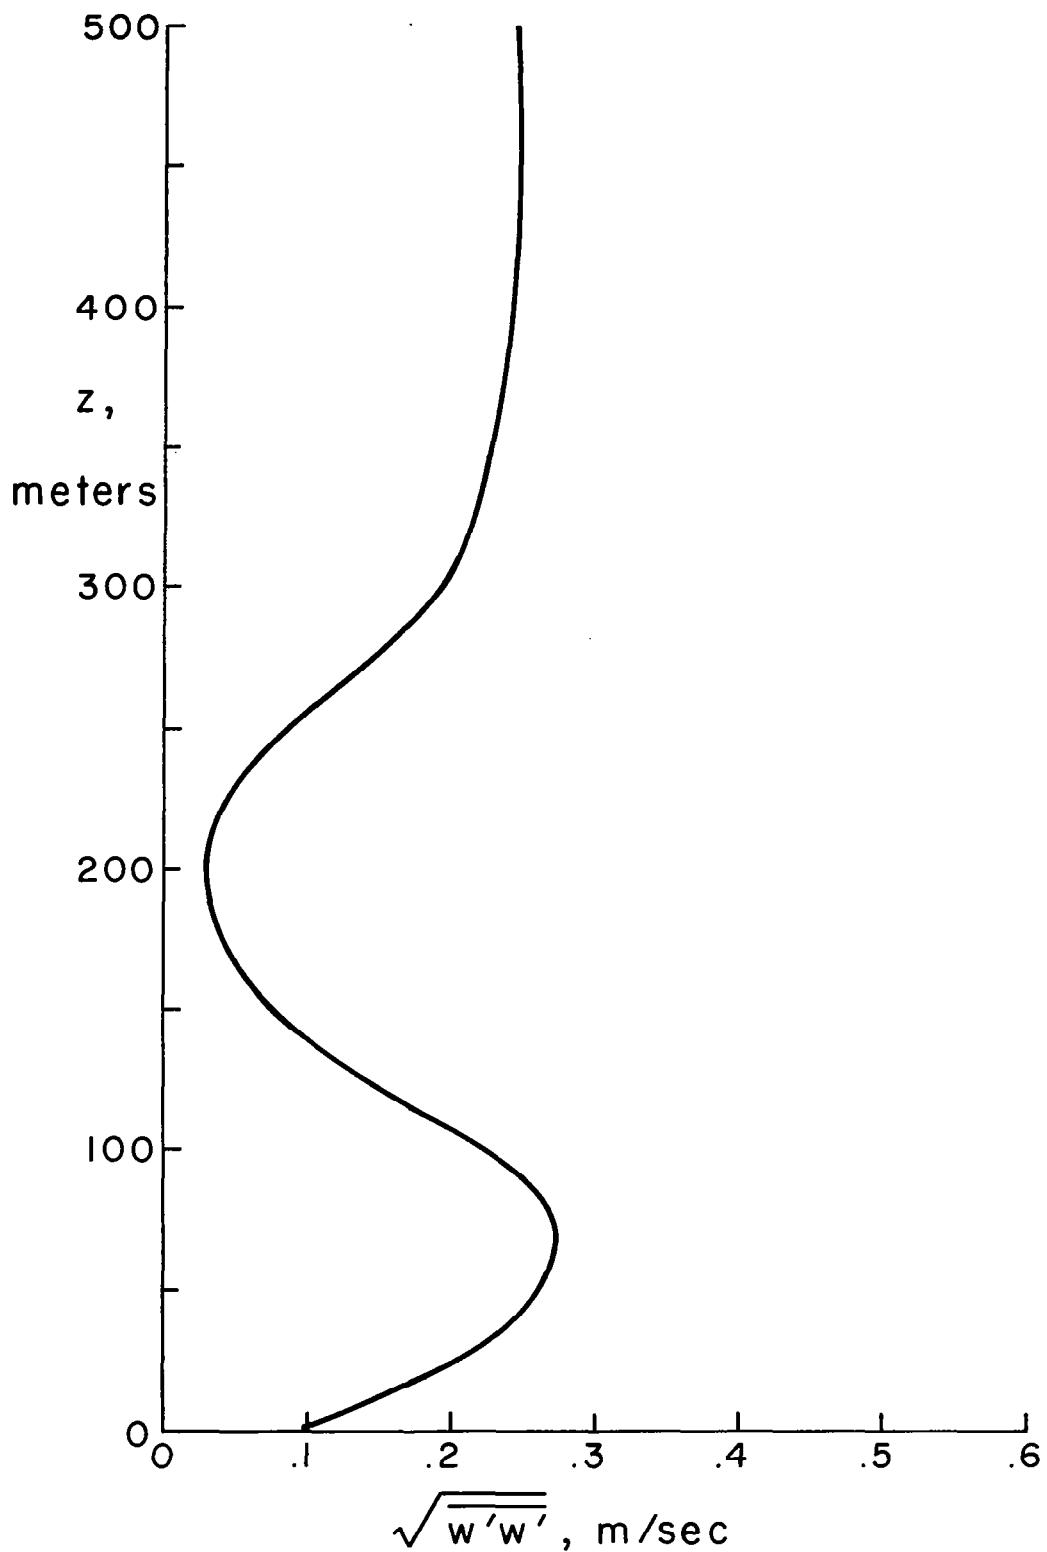
Figure 3.2.13. Altitude profile of variance of the vertical wind for Boston, December 17, 1973 accident.

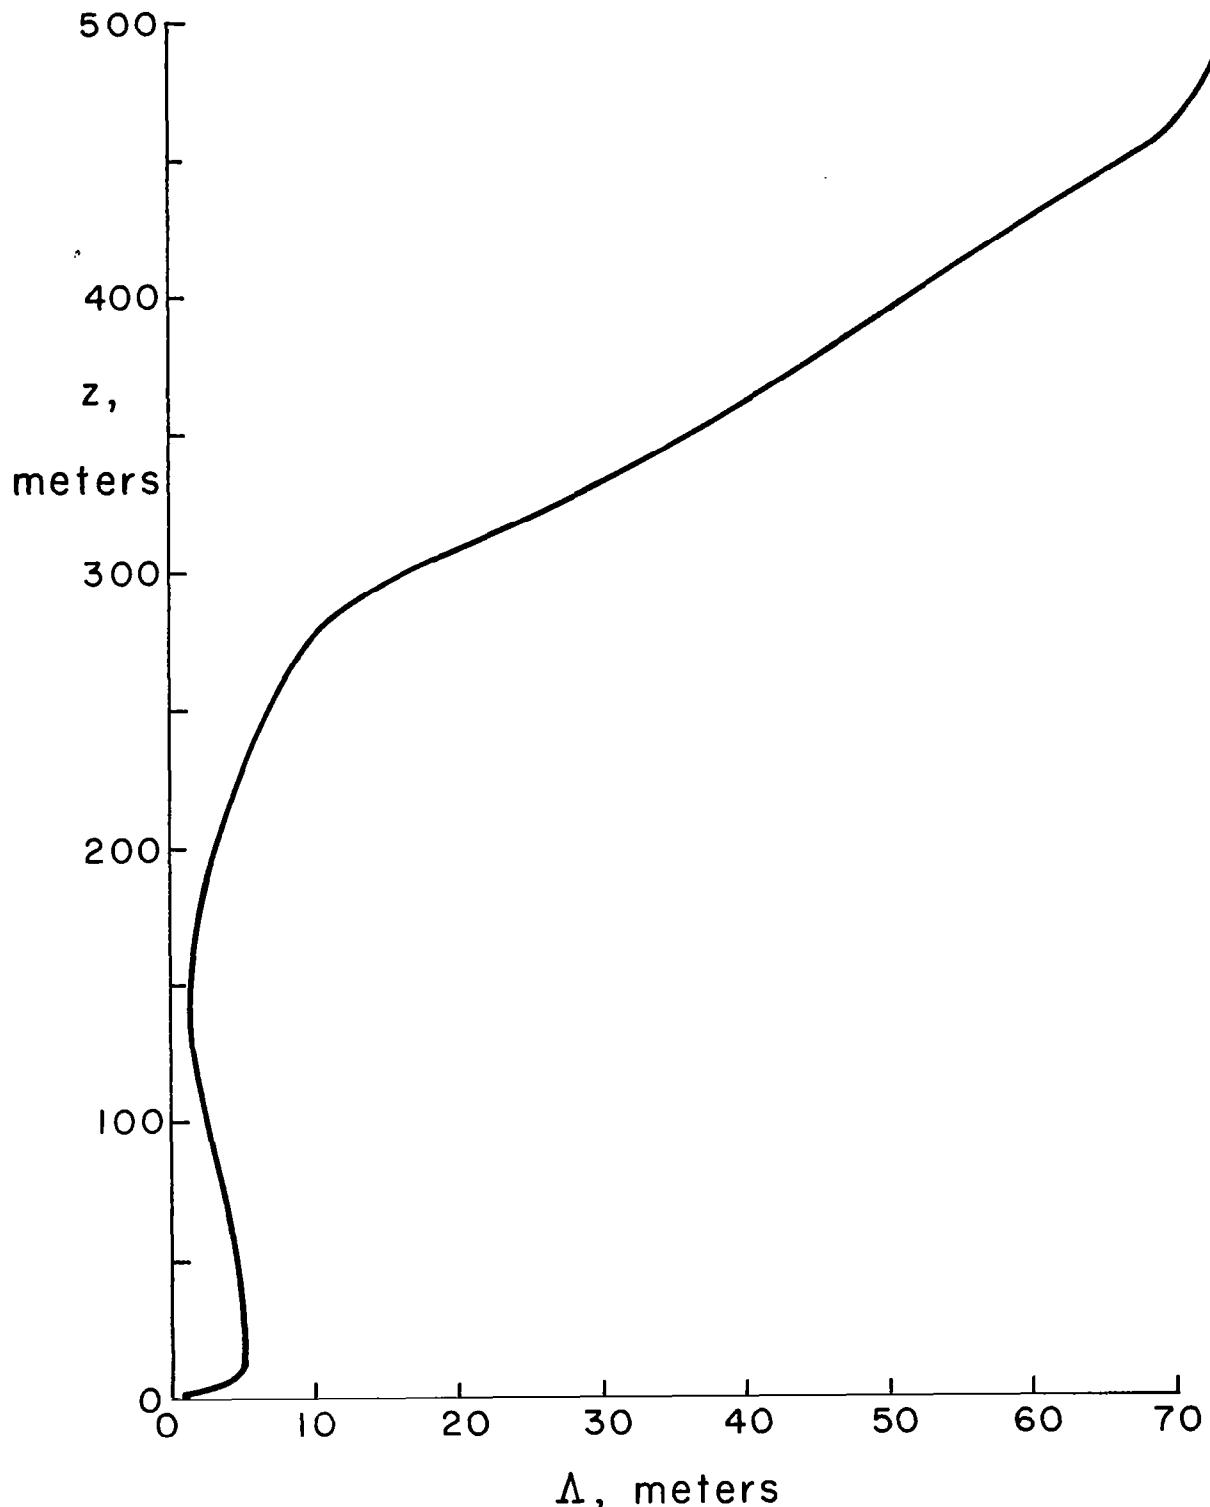
Figure 3.2.14. Altitude profile of scale of turbulence for Boston, December 17, 1973 accident.

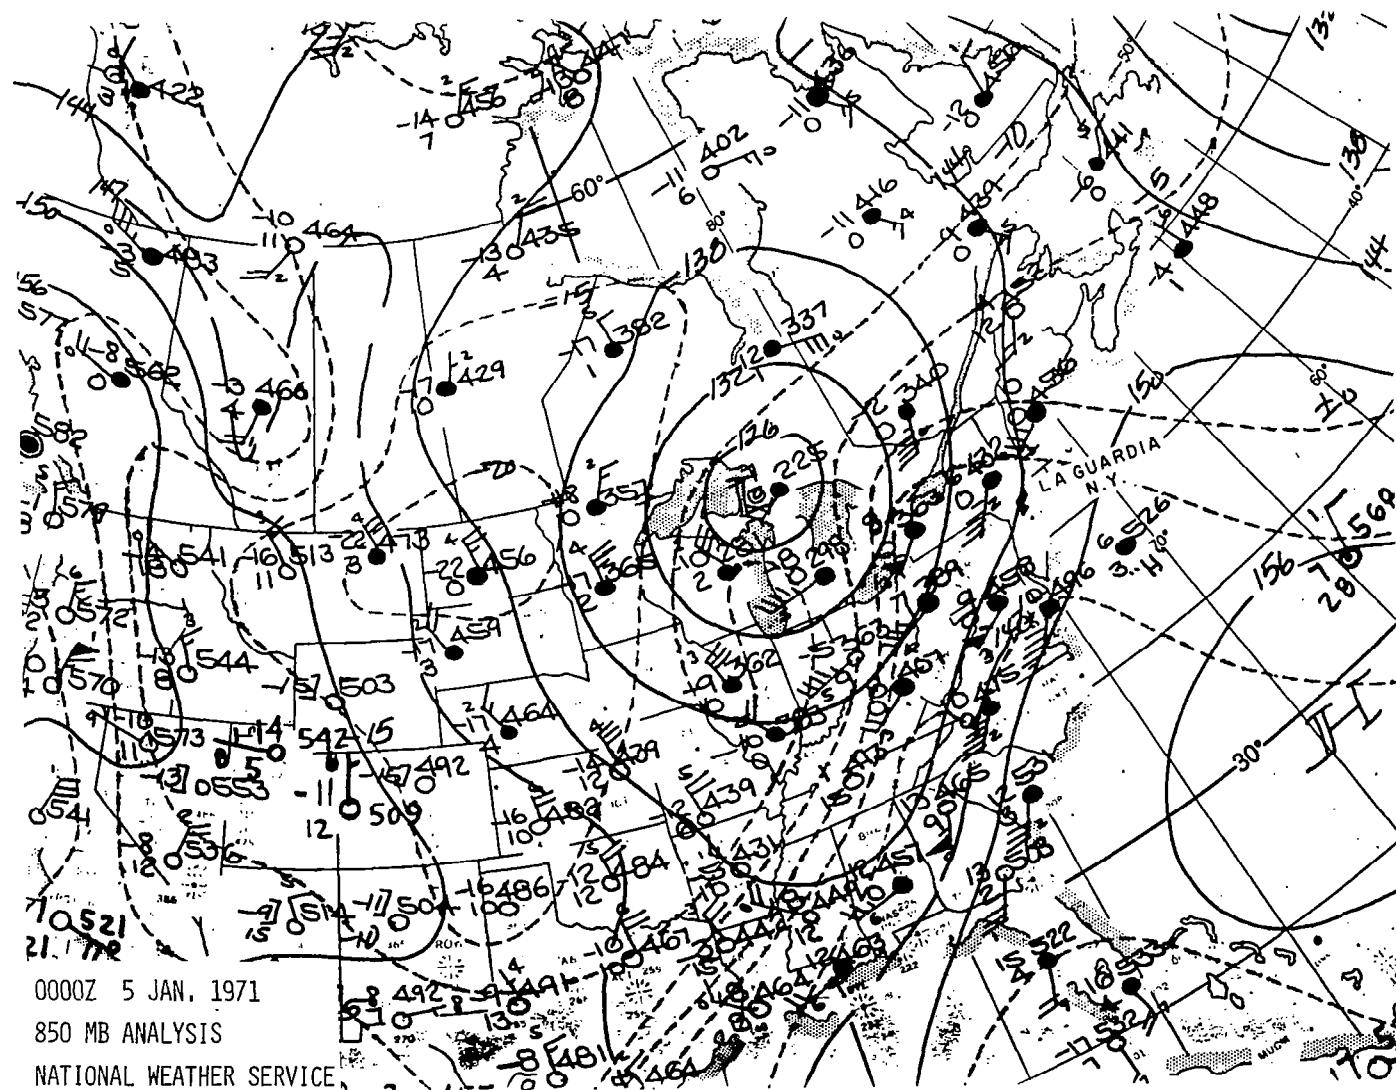
Figure 3.3.3. Late 850 mb chart for La Guardia Airport, January 4, 1971 accident.

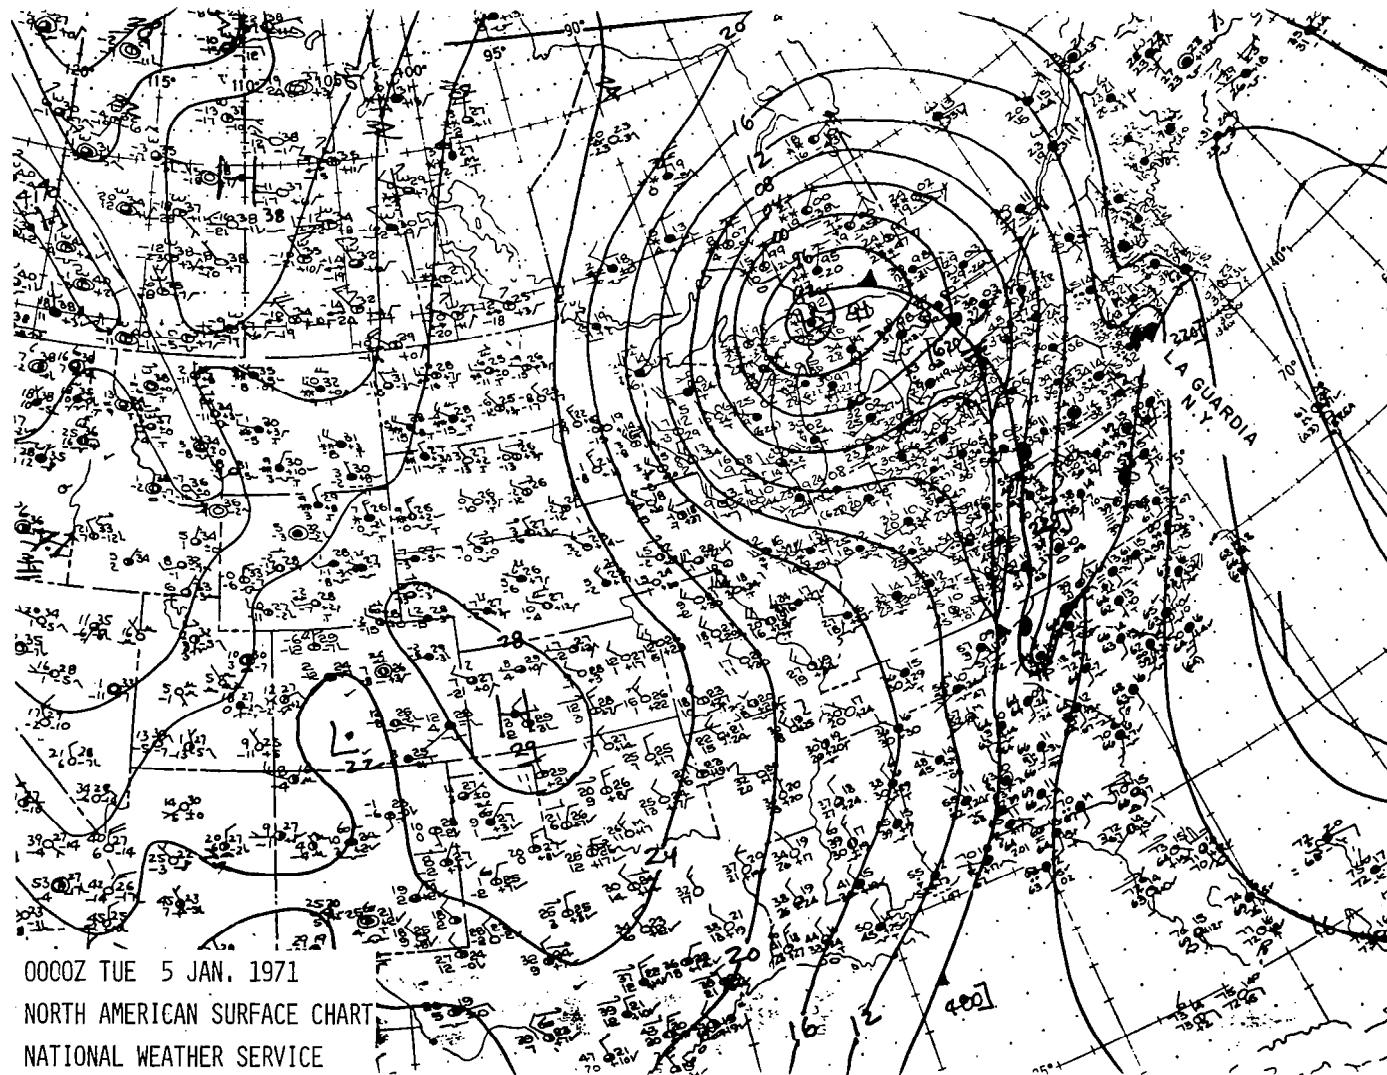
Figure 3.3.5. Late surface weather chart for La Guardia, January 4, 1971 accident.

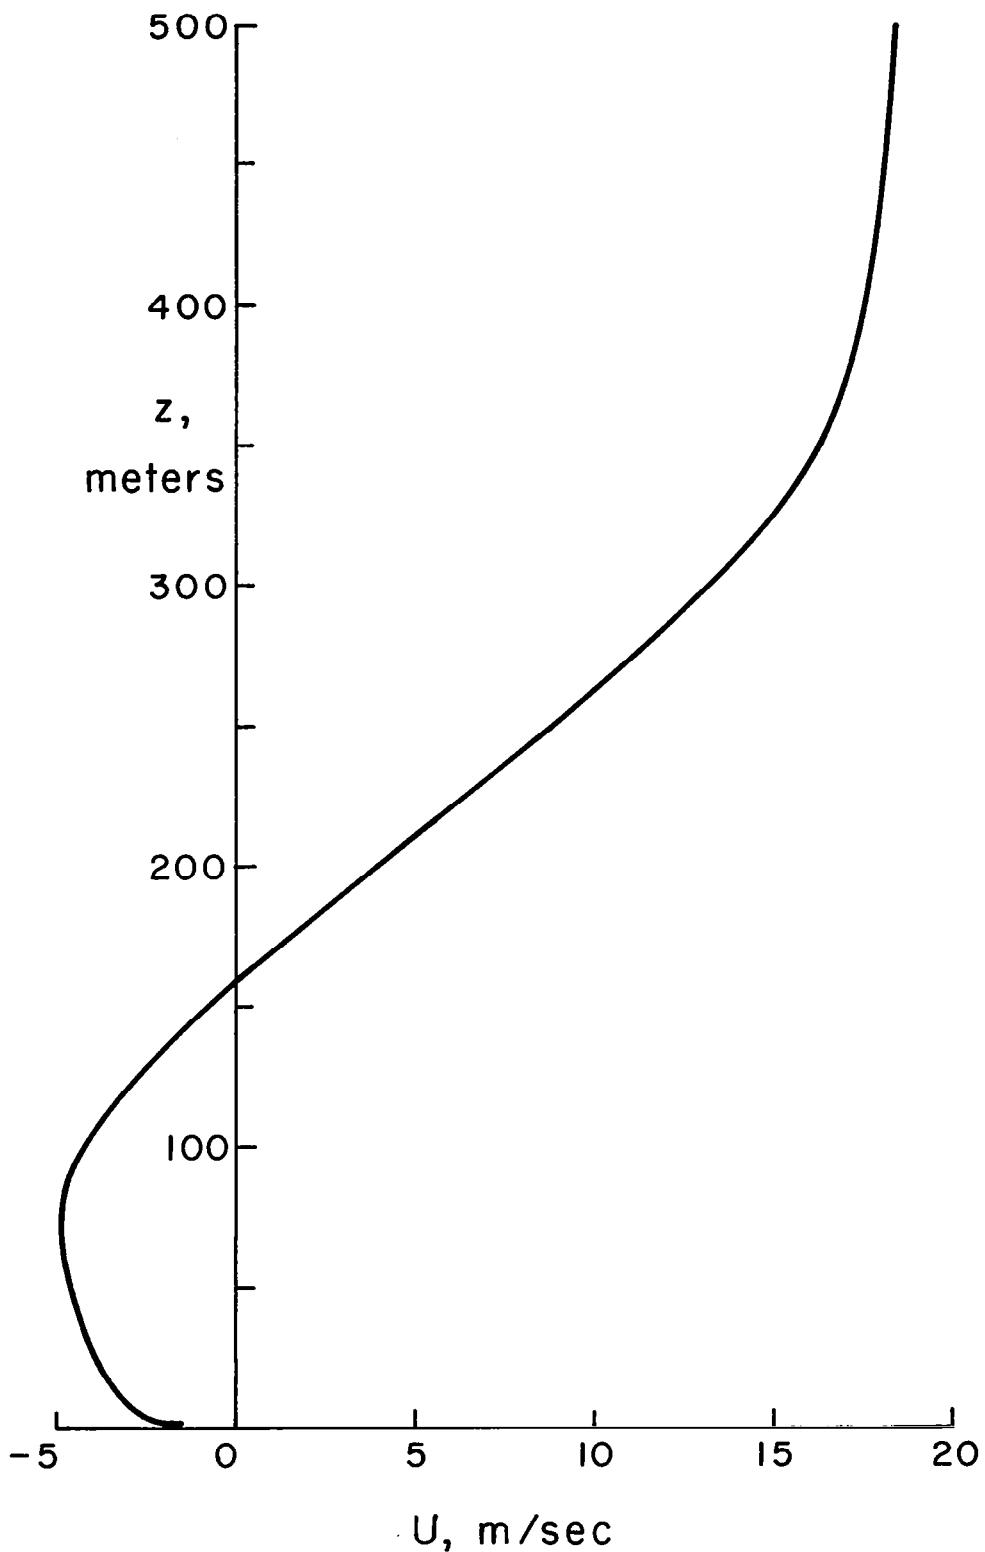
Figure 3.3.7. Altitude profile of mean wind velocity component parallel to runway for the La Guardia Airport, January 4, 1971 accident (+ U, tailwind).

As shown in figure 3.3.7 a 22 m/sec decrease in tailwind occurred between 350 m and 100 m. This is not only a large decrease in velocity but a reasonably large wind shear ( $.09 \text{ sec}^{-1}$ ). If power is not added during the descent phase the aircraft will drop below the glideslope and land short of the runway. This is particularly true if the visual cuing is degraded by rain, fog and darkness. The crosswind shear, in this case, is a factor of 3 lower (figure 3.3.8) and the maximum velocity variance is only 1.4 m/sec. The observed surface wind was 6 m/sec from  $60^\circ$  and that computed from our model at an altitude of 10 m, is 3.6 m/sec from  $74^\circ$ .

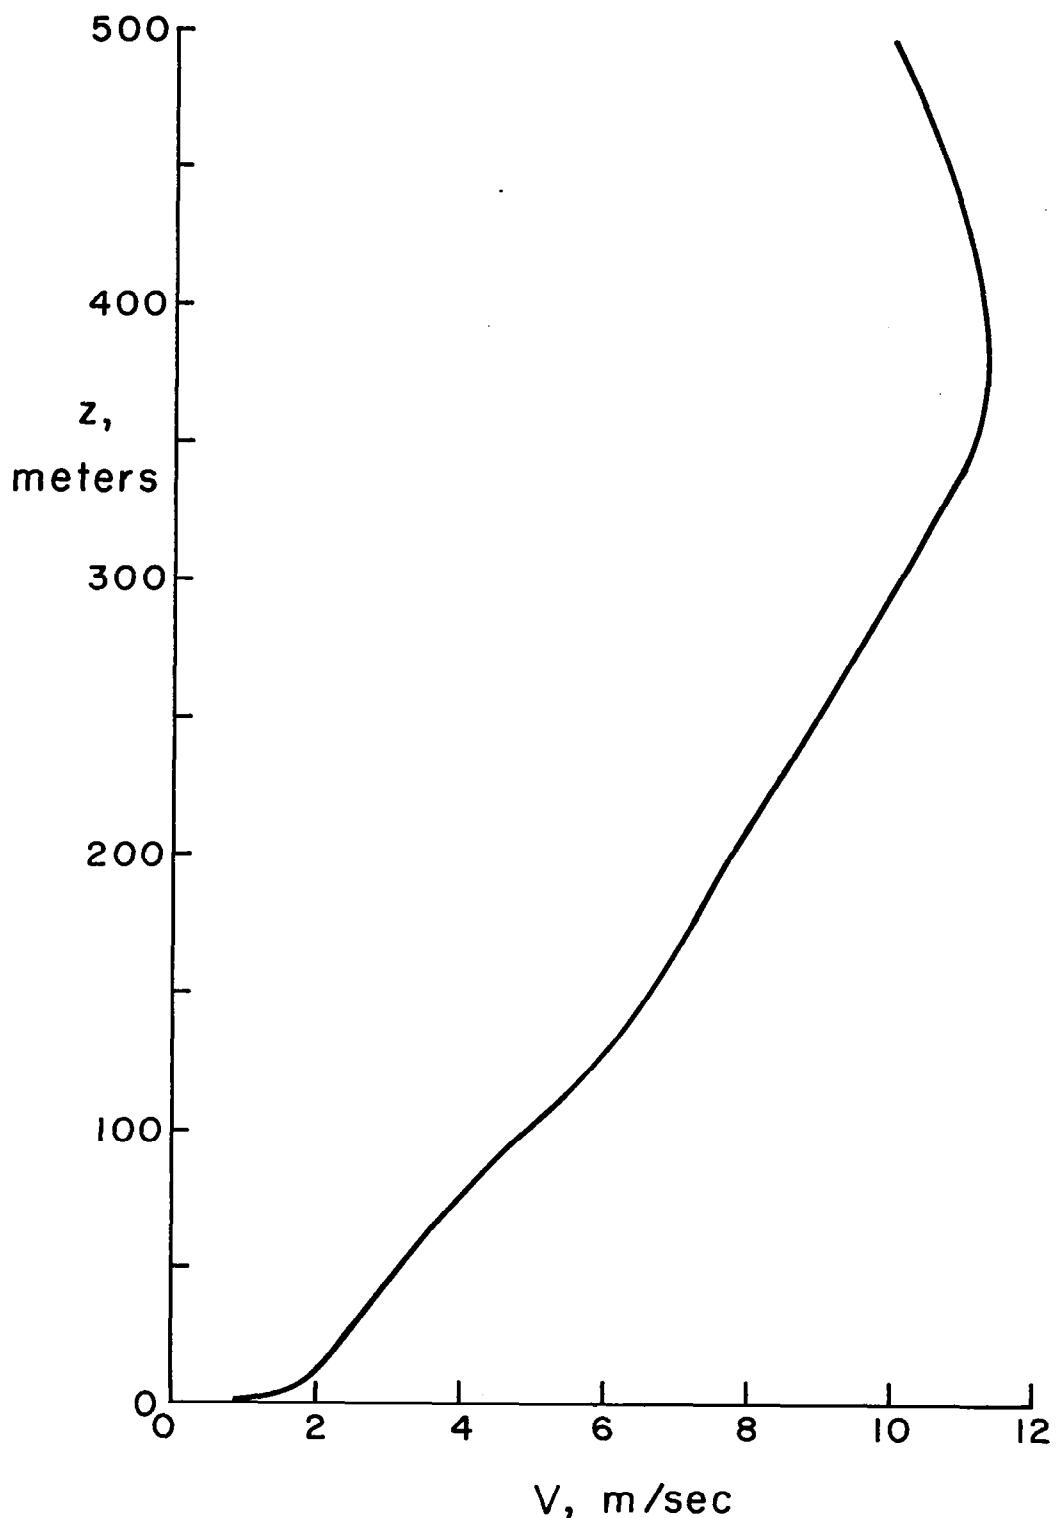
Figure 3.3.8. Altitude profile of mean wind velocity component perpendicular to runway for the La Guardia Airport, January 4, 1971 accident.

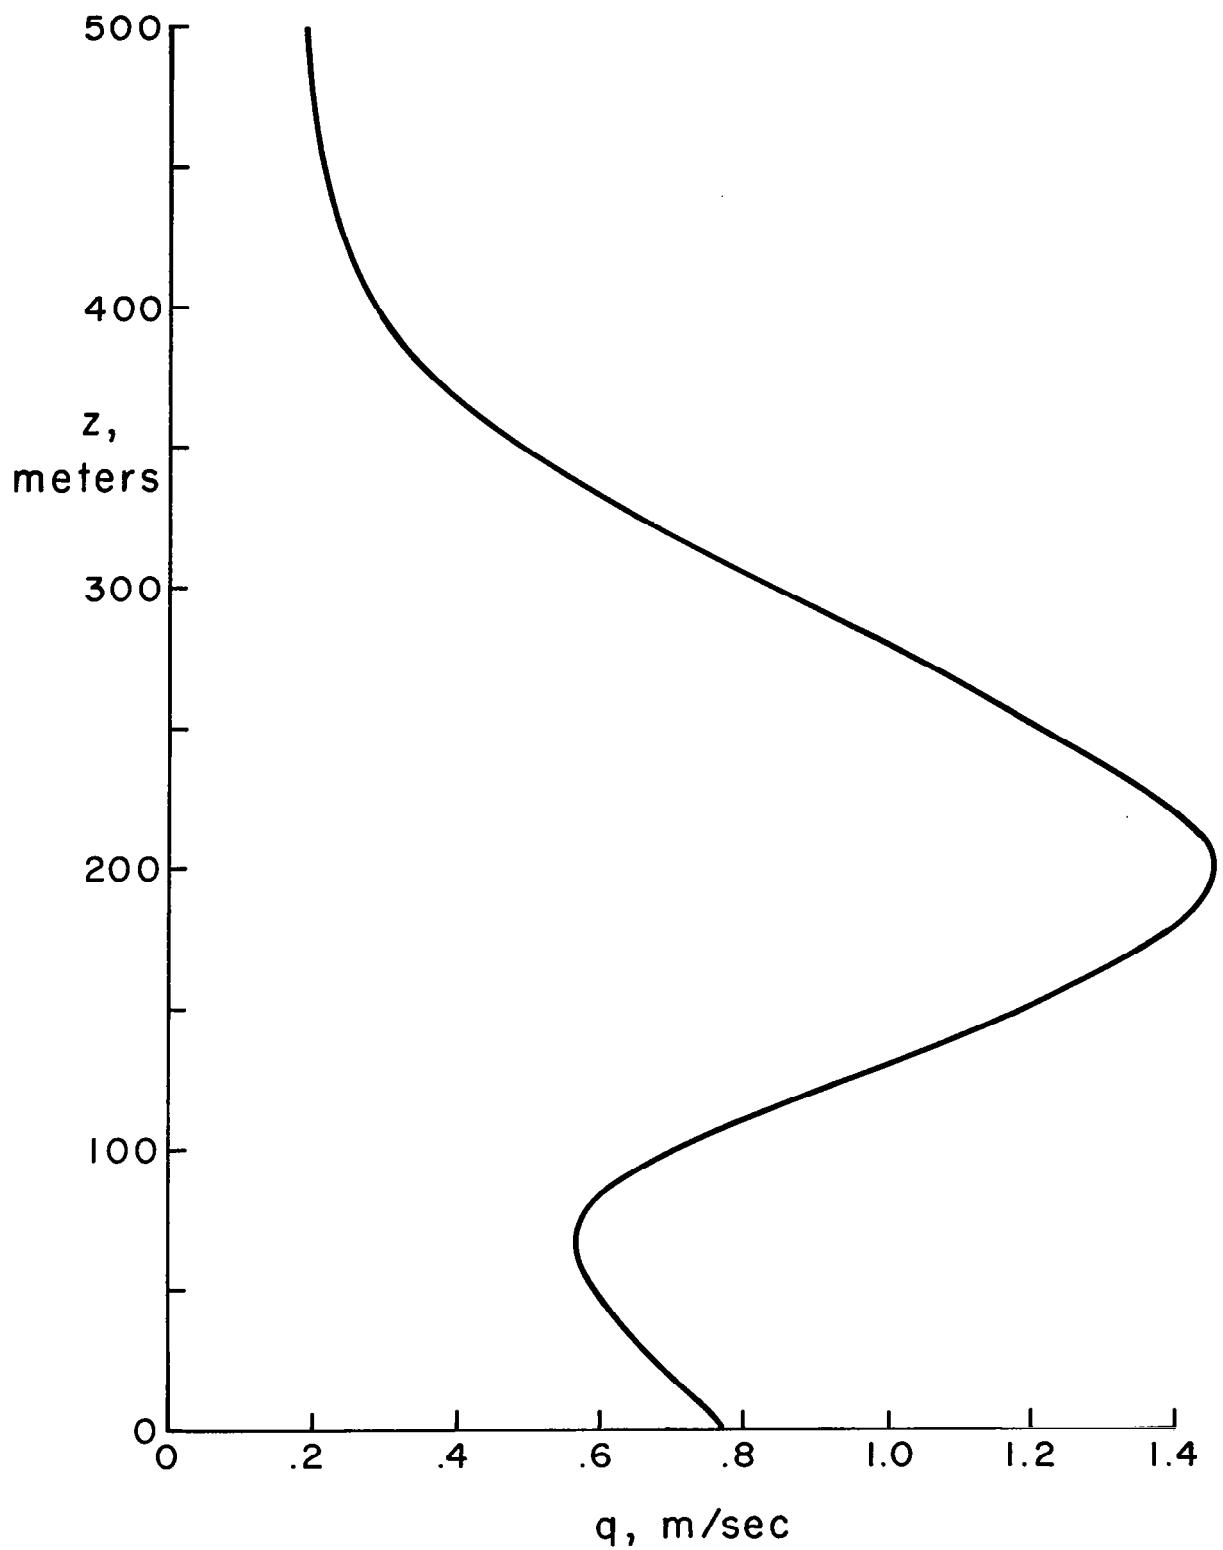
Figure 3.3.9. Altitude profile of variance of the total velocity variance for La Guardia, January 4, 1971 accident.

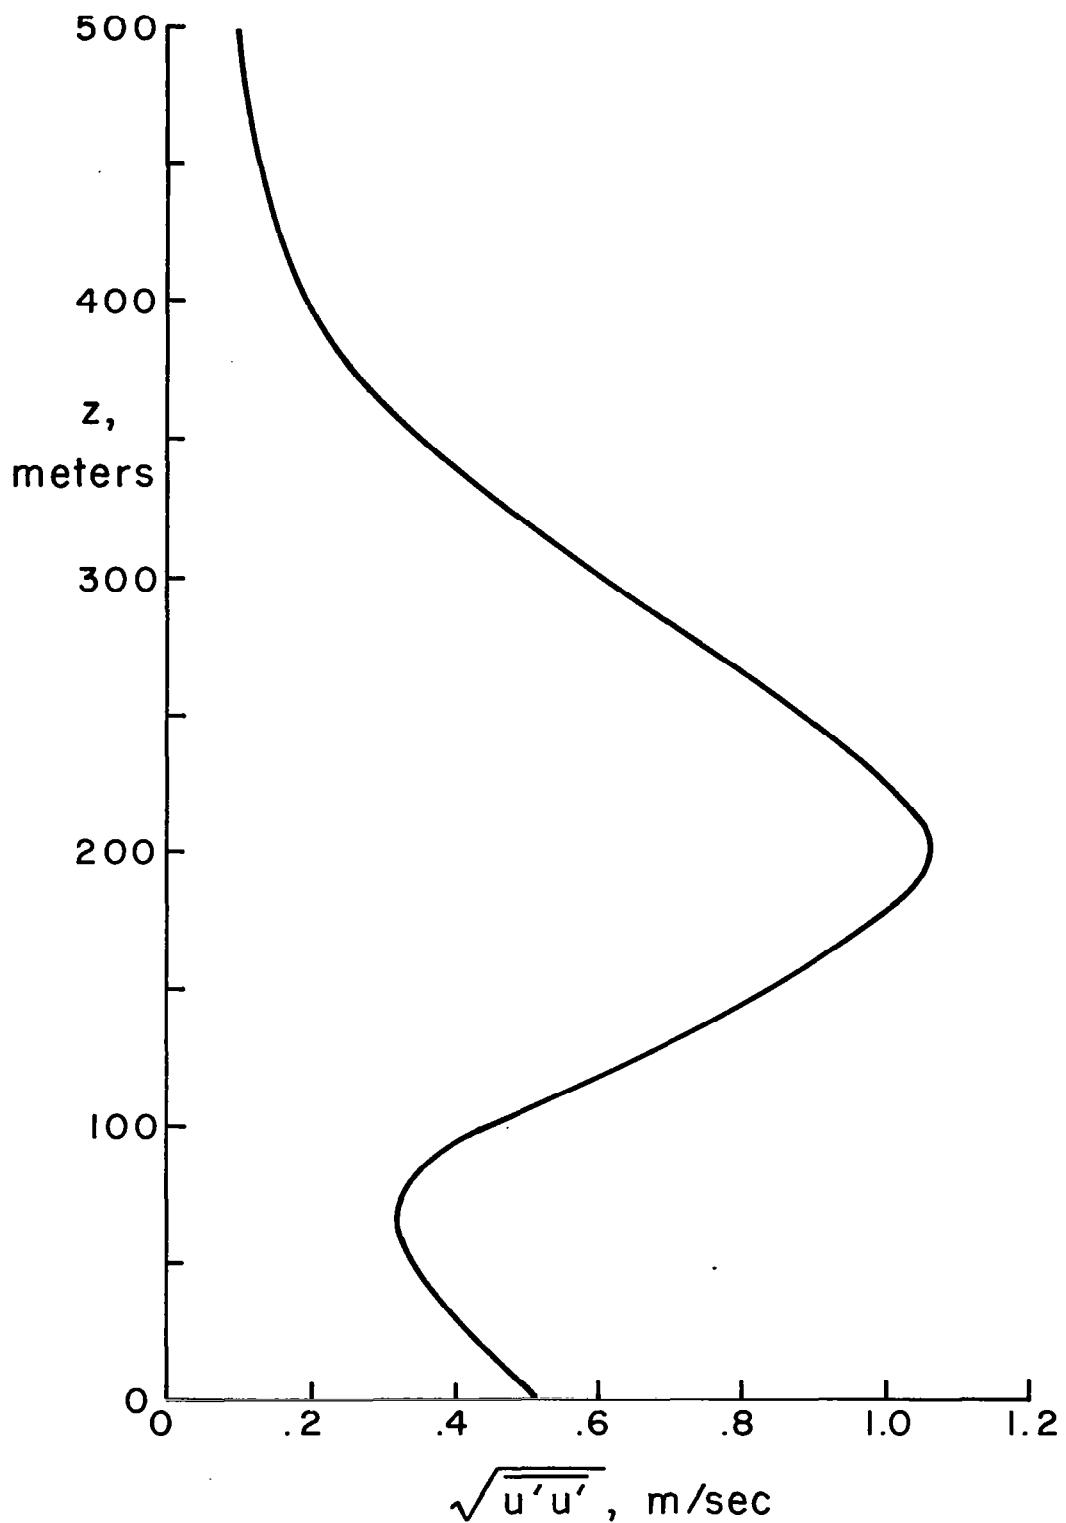
Figure 3.3.10. Altitude profile of variance of the wind parallel to runway for La Guardia Airport, January 4, 1971 accident.

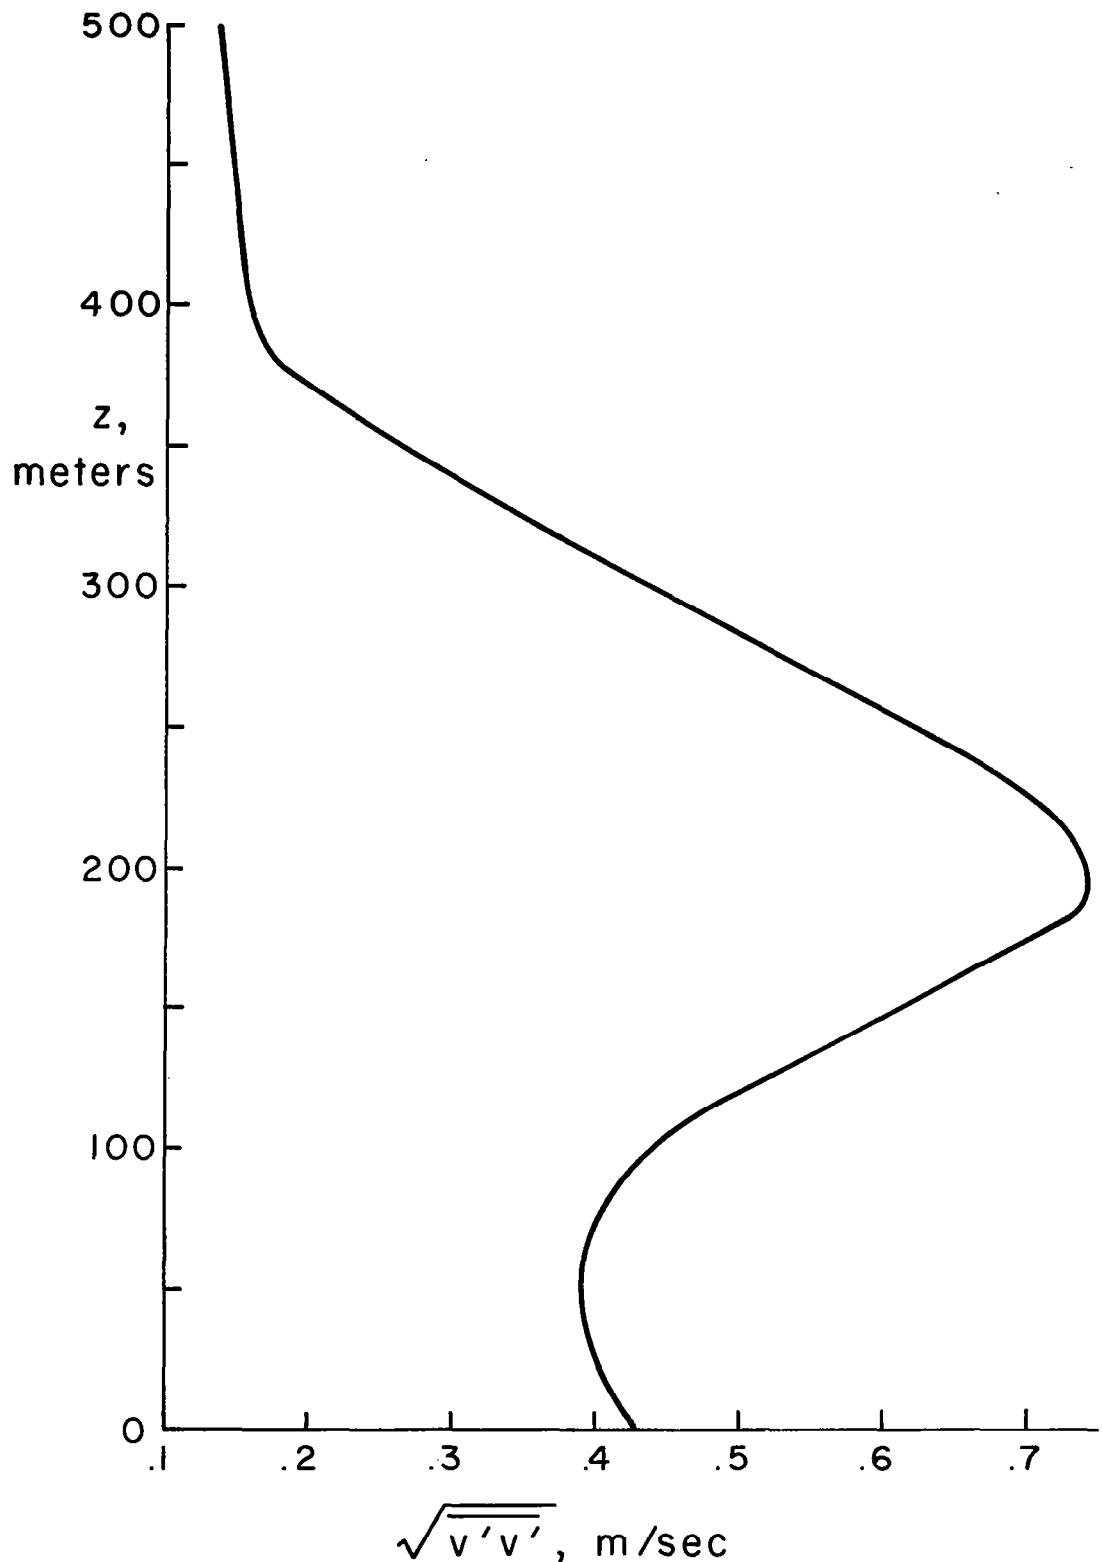
Figure 3.3.11. Altitude profile of variance of the wind perpendicular to runway for La Guardia Airport, January 4, 1971 accident.

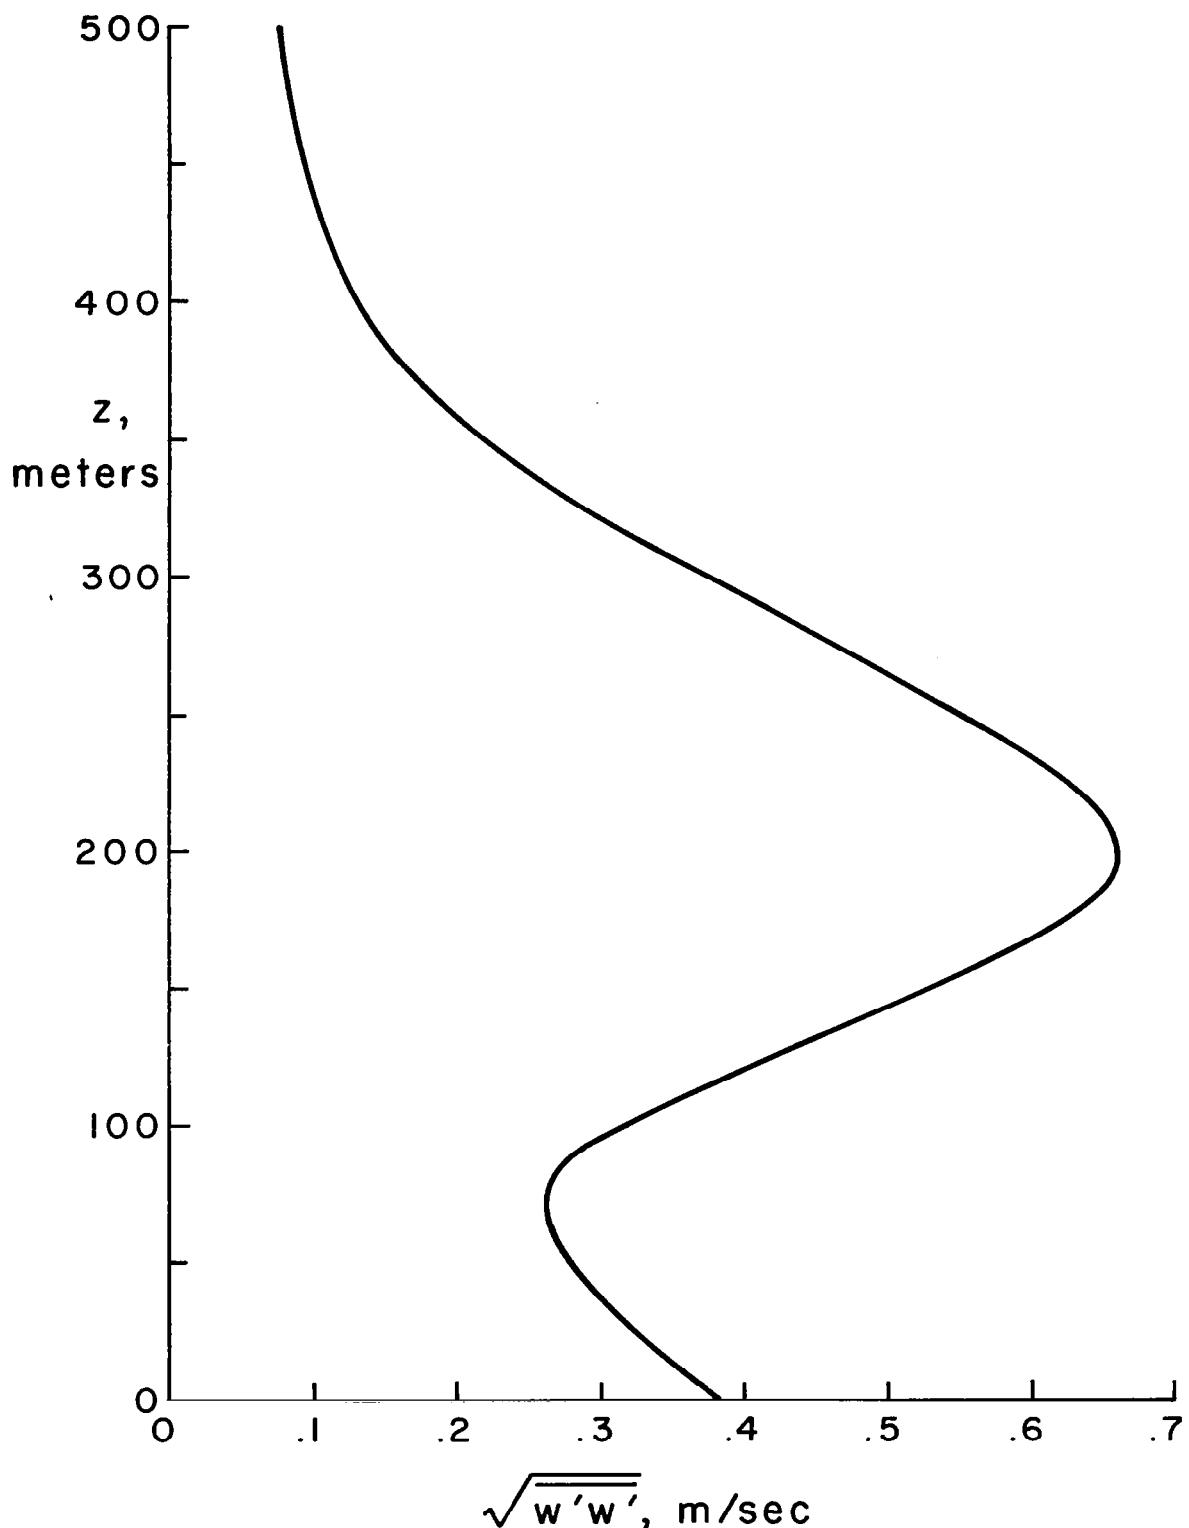
Figure 3.3.12. Altitude profile of variance of the vertical wind for La Guardia Airport, January 4, 1971 accident.
